Manhole Inspection Summary

Manhole # S33EE_009MH

Insp Date: **2/21/07 11:56 AM**

Location Address: **2 PRESTON ST**

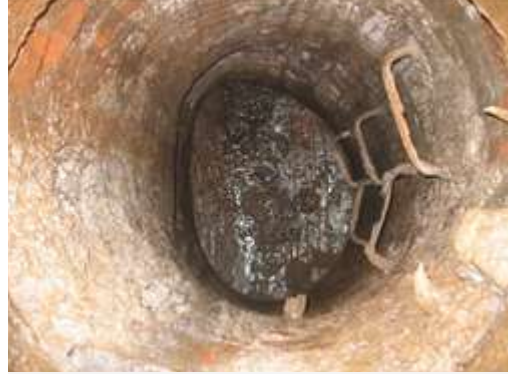
Top View

Corroded and missing steps. Channel debris.

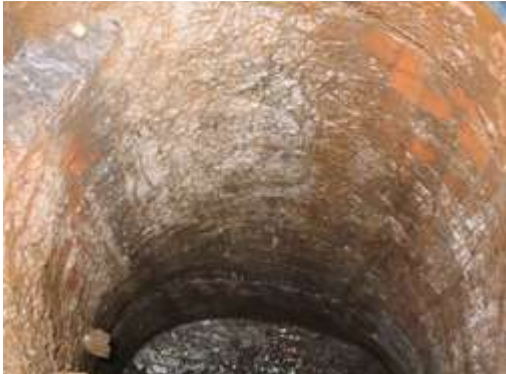
Defect

Frame leaks. Adjustment and Corbel infiltration.

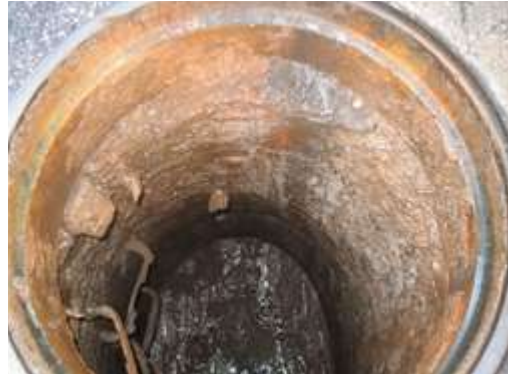
Defect

Frame offset. Adjustment deterioration, loose brick and infiltration. Corbel and Barrel infiltration.

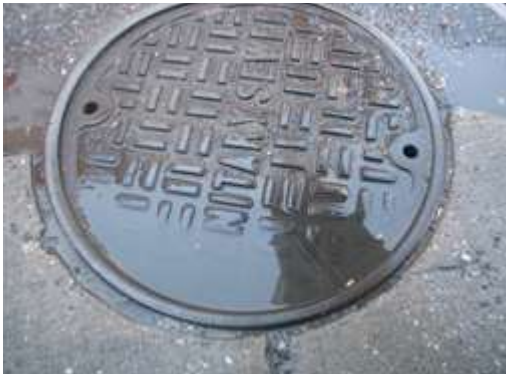
Defect

Subject to ponding.

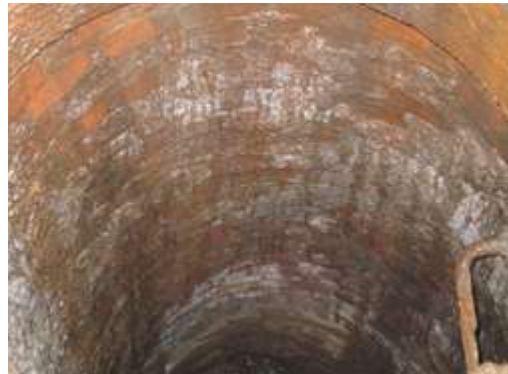
Defect

Frame leaks. Adjustment, Corbel and Barrel infiltration.

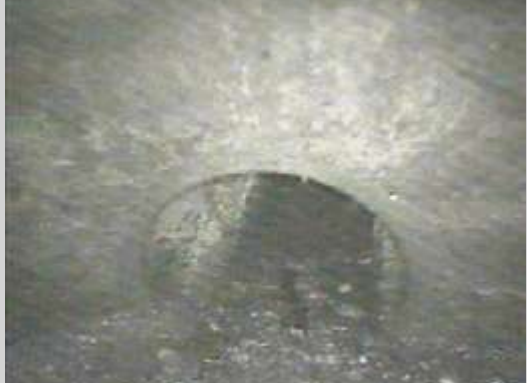
8 in. Circular Gravity Sewer
Pipe Out @ 12 O'Clock

Deposits: ☐ None ☒ **Mud** ☐ Sludge ☒ **Debris** ☒ **Grease**

Silt Depth: **0.5** (in.) Deposits Extent: **Light**
